Mulkey-Monache Grazing Allotments, Golden Trout Wilderness
Head Cut and Photo Point Monitoring, 2003 and 2011 (DRAFT)

By: Casey Shannon, Hydrologic Technician
Inyo National Forest, Supervisor's Office
January, 2012

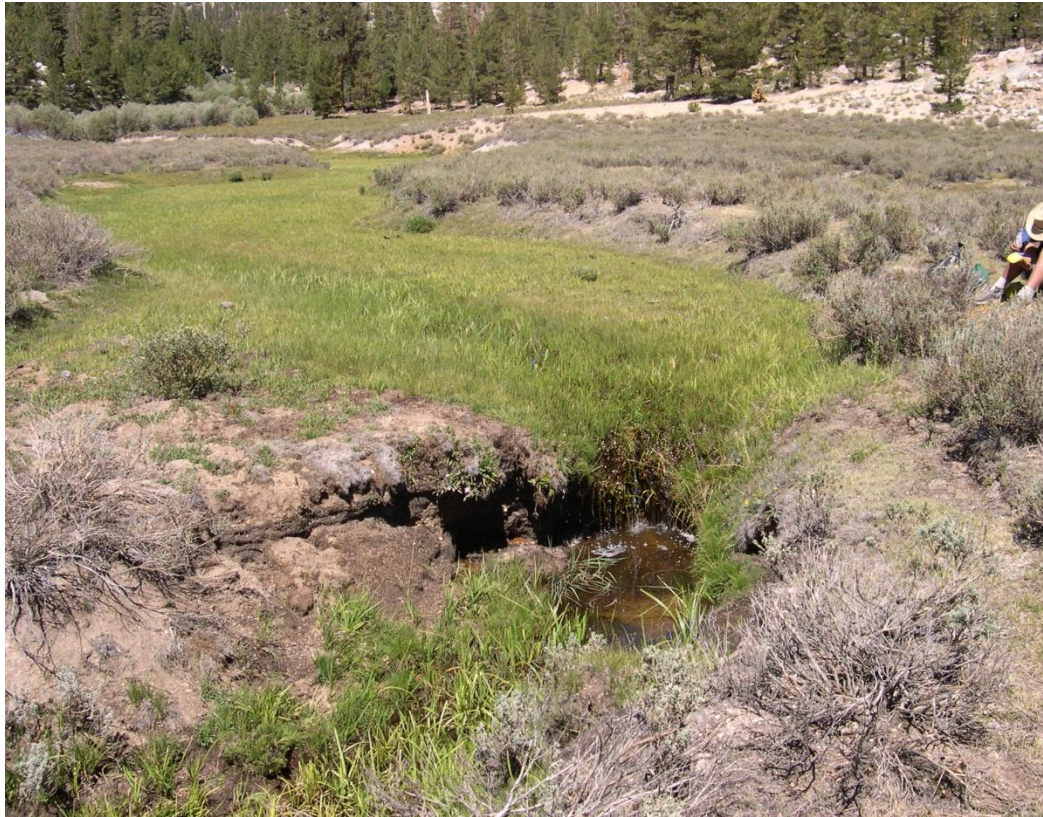
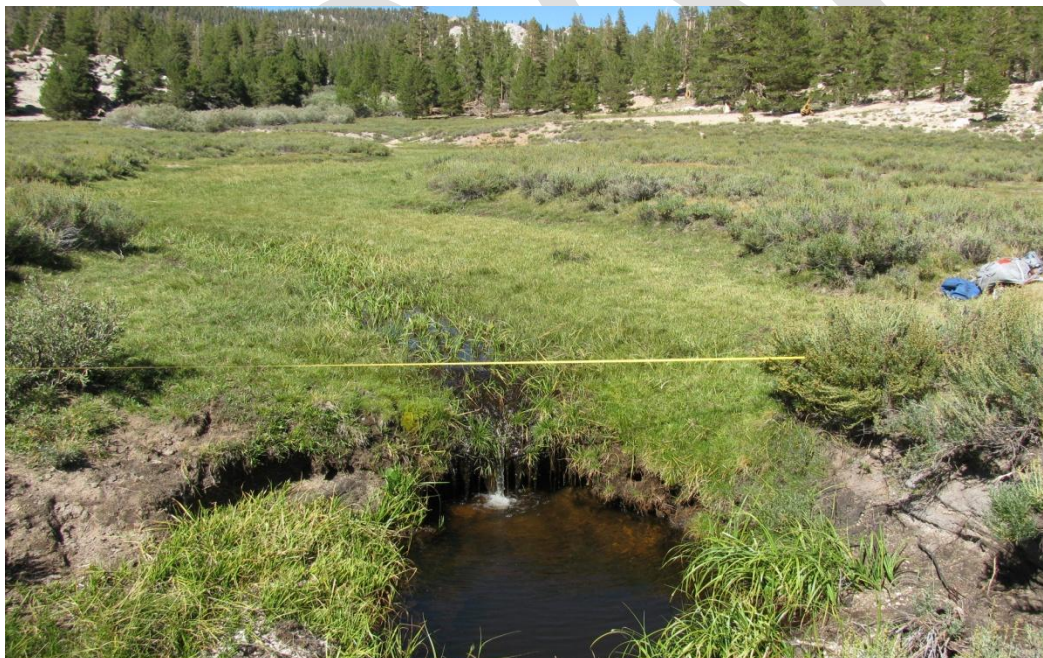
Above photo: Headcut 372 (HC-372) Mulkey Meadow on Cow Camp Stringer, August 2003. Steeply faced HC migrating into recovering floodplain of old incised channel. Deep organic soil exists at site. **Below photo:** HC 372 with photo re-taken August 2011. Scour pool has widened below HC and has caused minor bank erosion below HC. HC migration is slow, 0.72 meters of upstream movement. Similar site condition to HC-371 just downstream from HC-372 where deep organic sod layer and well rooted vegetation holds soil together and is resistant to rapid erosion under normal runoff conditions. Site is a good candidate for HC stabilization work.

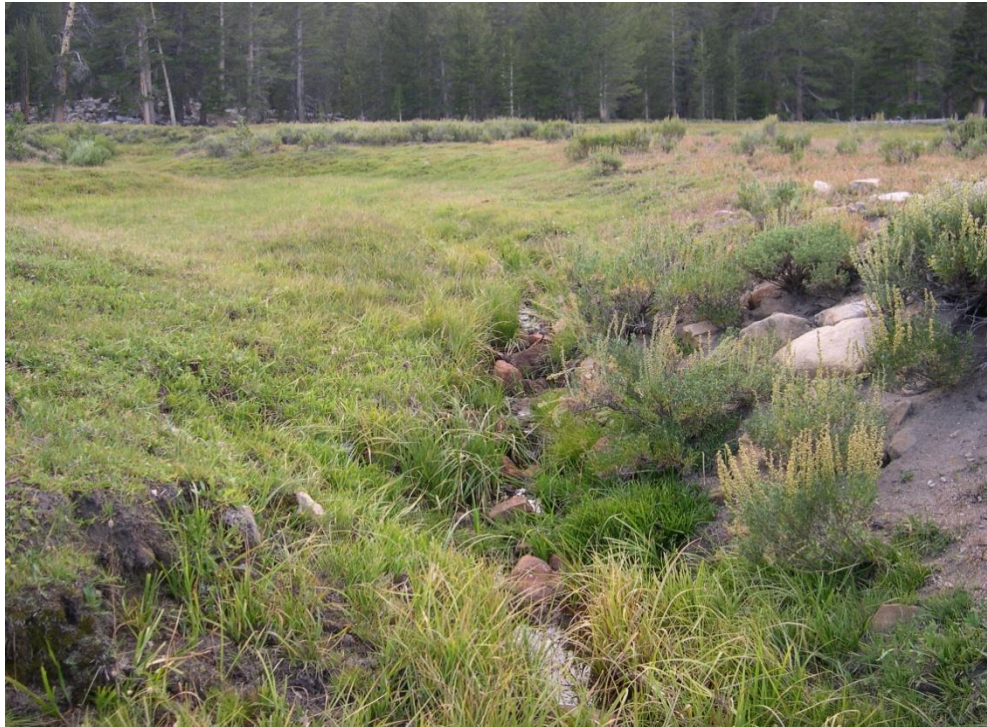
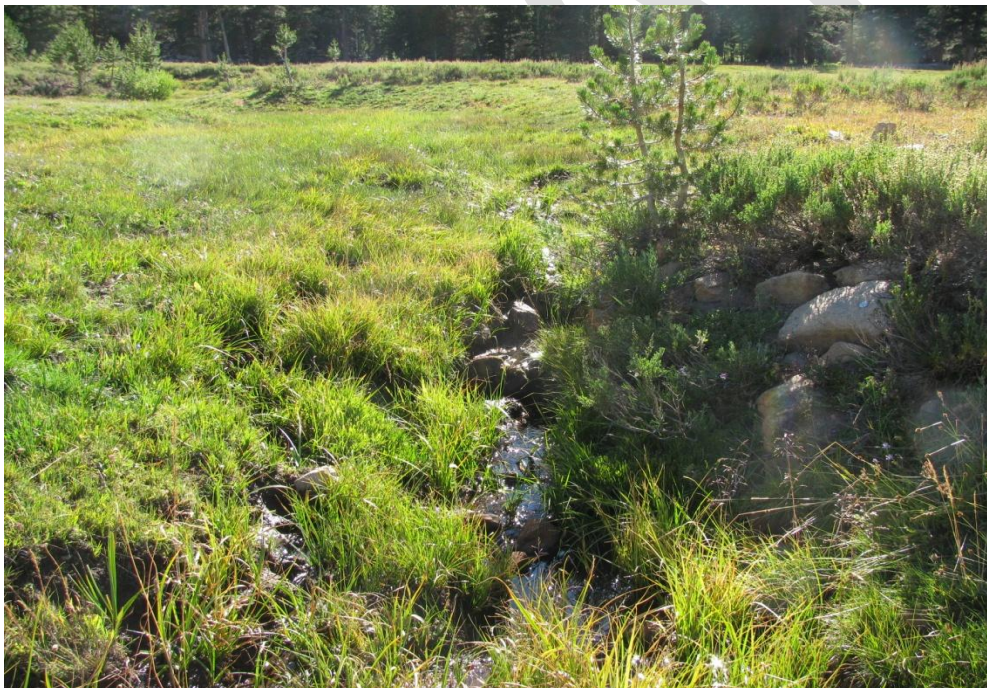
Above photo: Treated Head Cut 360 (THC-360) Bear Meadow, August 2003. Site is a treated headcut done in the 1990's, a rock and filter cloth armoring. At the time of observation the treatment was stable and within prescription. Some bare soil area existed around the treatment. **Below photo:** THC-360, photo re-taken August 2011. Treatment is fully functional and meeting prescription. Surrounding banks have filled in with vegetation furthering stability of the treatment. Vegetation is developing into the rock chute and holding soil, no need for maintenance.

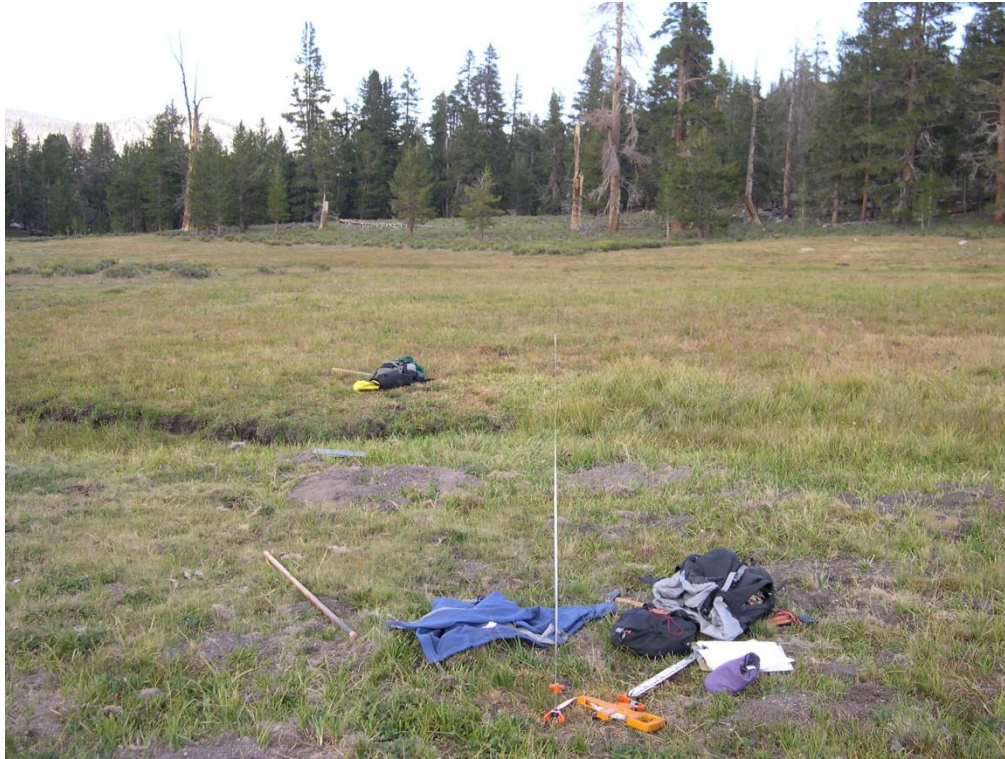
Above photo: Head Cut 359 (HC-359) Bear Meadow, August 2003 looking across top of headcut (transect tape crosses HC face). Moderate sized gully exists below HC, gully banks show exposed soil along gully edges. **Below photo:** HC 359 Bear meadow with photo re-taken August 2011. HC has migrated 0.60 meters since 2003 a cow skull is seen at the current HC location. Migration is slow due to a resilient, well developed sod layer and strong vegetation rooting into deep organic soil. Gully banks below HC show increased soil erosion and bare soil. Gopher activity noticeable, overall sod layer in meadow appears same, not full. HC has right conditions for stabilization.

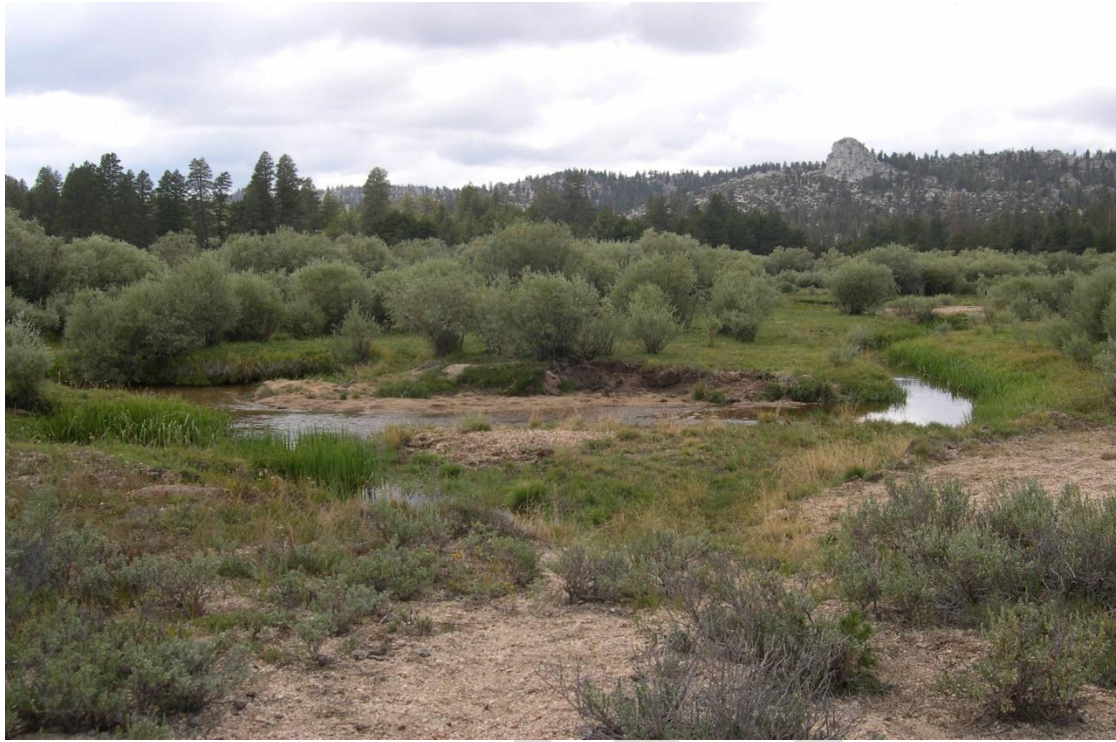
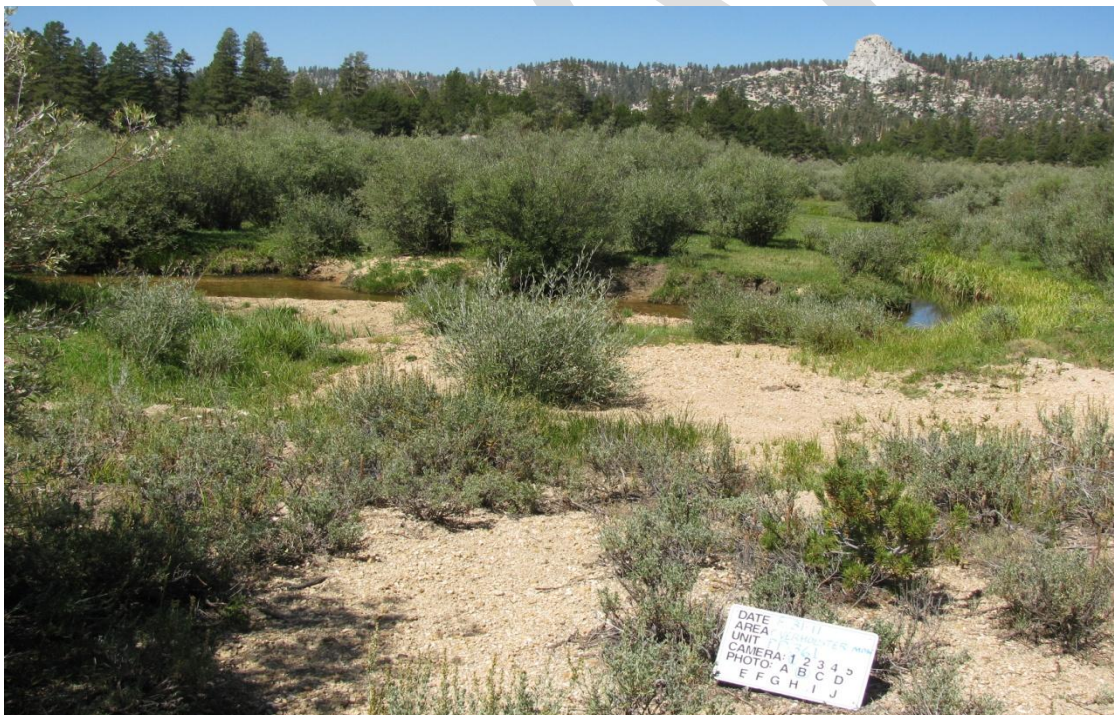
Above photo: Photo point 361 (PP-361) Overholster Meadow, August 2003. Site is a stock crossing point on Mulkey Creek with eroded stream banks and missing vegetation along channel. Small back water pool exists in foreground. **Below photo:** PP-361 photo retaken August 2011. Eroded stream banks and channel edge has shown slight to moderate increase of riparian vegetation, unstable bare soil still exists. Overall riparian vegetation is more robust, and backwater pool in foreground has filled in with sediment. Willows are denser. Not a lot of change.

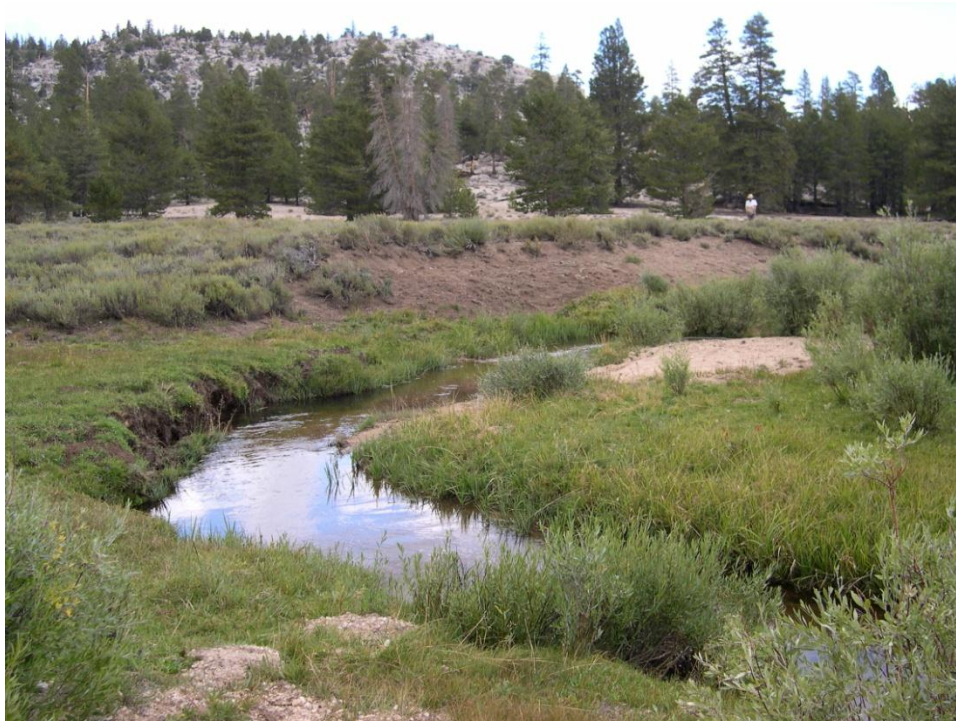
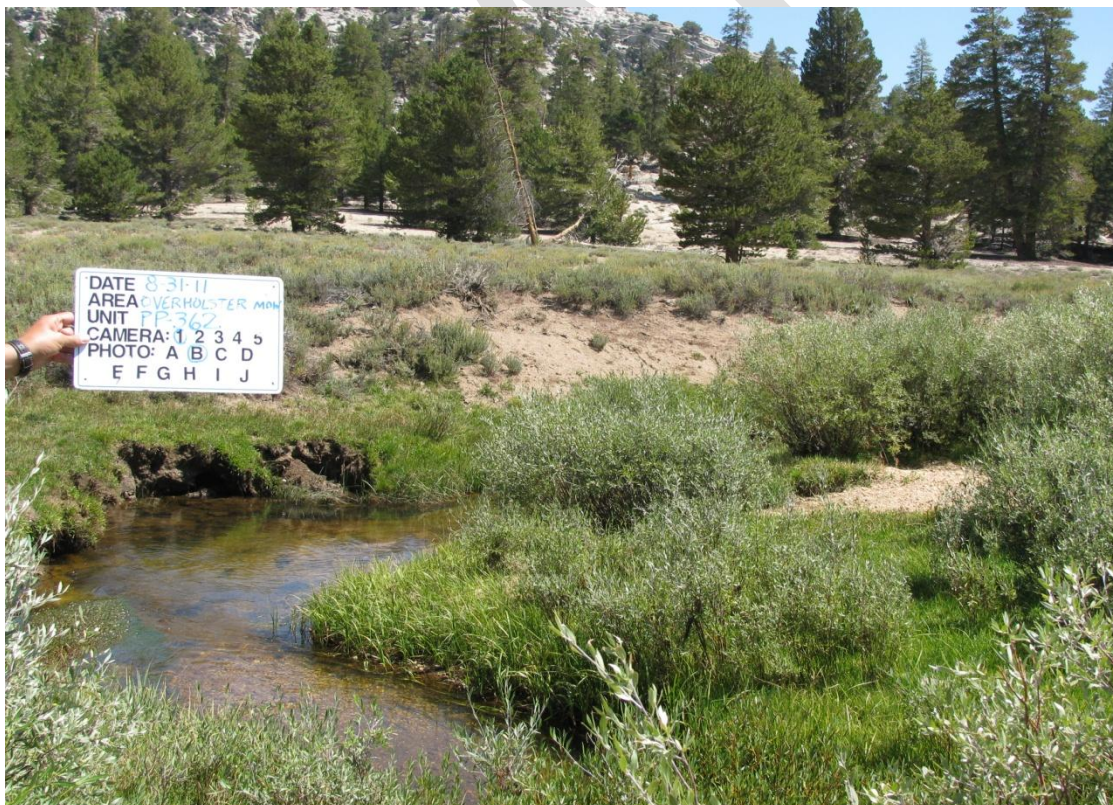
Above photo: Photo point 362 (PP 362), Overholster Meadow August 2003. Site is an eroded stream bank on outward meander bend on Mulkey Creek with barren terrace slope in background. **Below photo:** PP-362 with photo re-taken August 2011. Stream bank erosion is ongoing and slightly increased from peak flows. Riparian vegetation has increased moderately, mostly with willow development adding to stability. Cover on terrace bank has slightly increased. Point bar in right of photo has slow increase in vegetation cover.

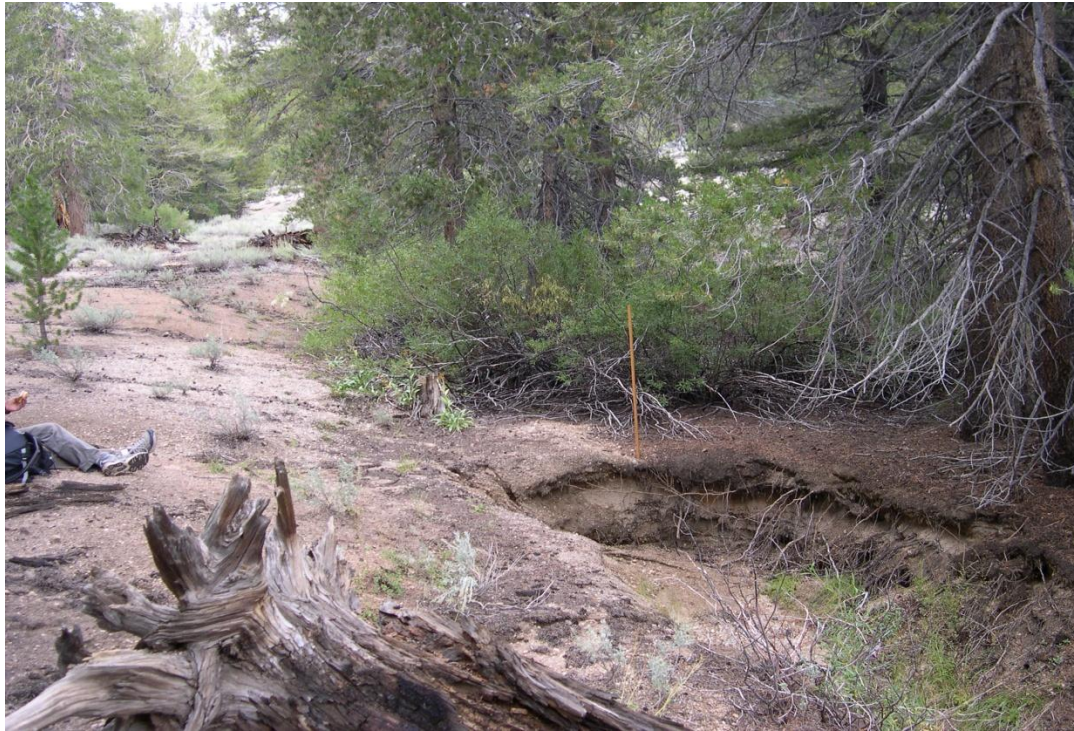
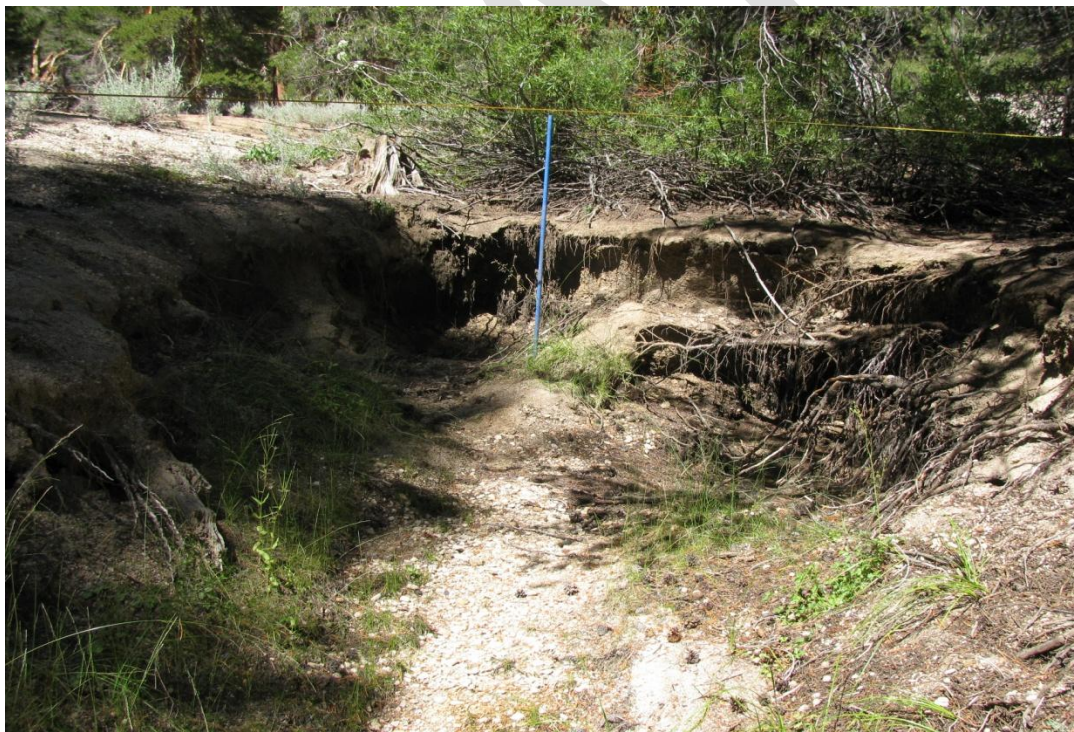
Above photo: Head Cut 363 (HC-363) north tributary branch of Overholster Meadow August 2003. A large HC located in mineral soil with active erosion. Found in an ephemeral flowing channel with high erosion potential. This HC is at the top of the historic gully on the north branch of Overholster. **Below photo:** HC-363 with photo re-taken August 2011. HC has migrated 2.30 meters and gully below has widened and deepened considerably (see HC data tables). Migration was limited by willow and pine tree roots above that held head cutting in check. Without root slowing, erosion rates could be higher. The HC is a source of sediment to Mulkey Creek. Site is difficult to treat, not recommended for treatment.

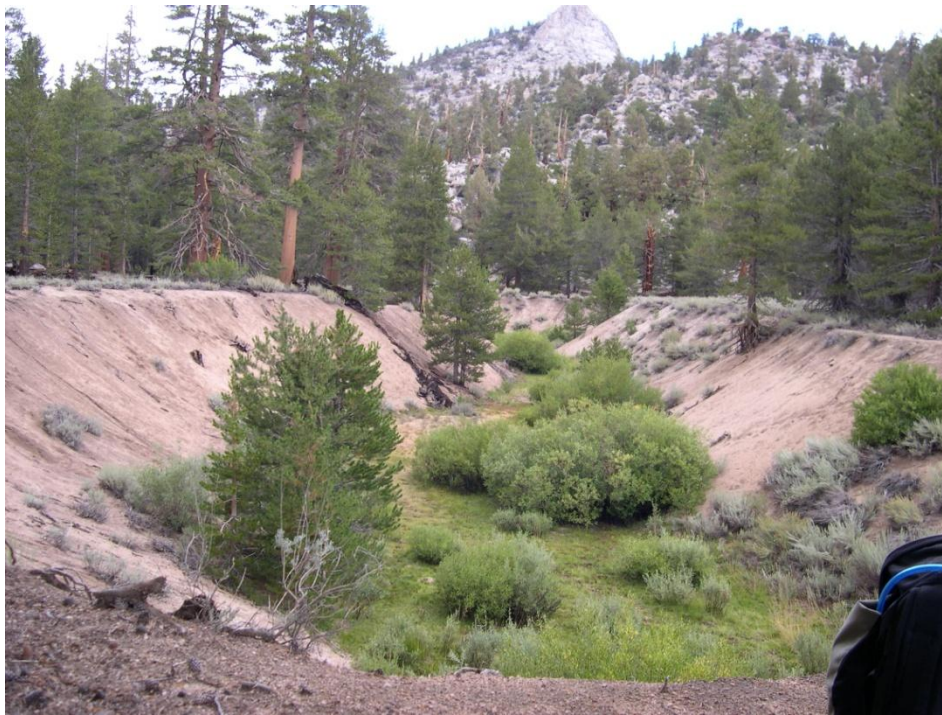
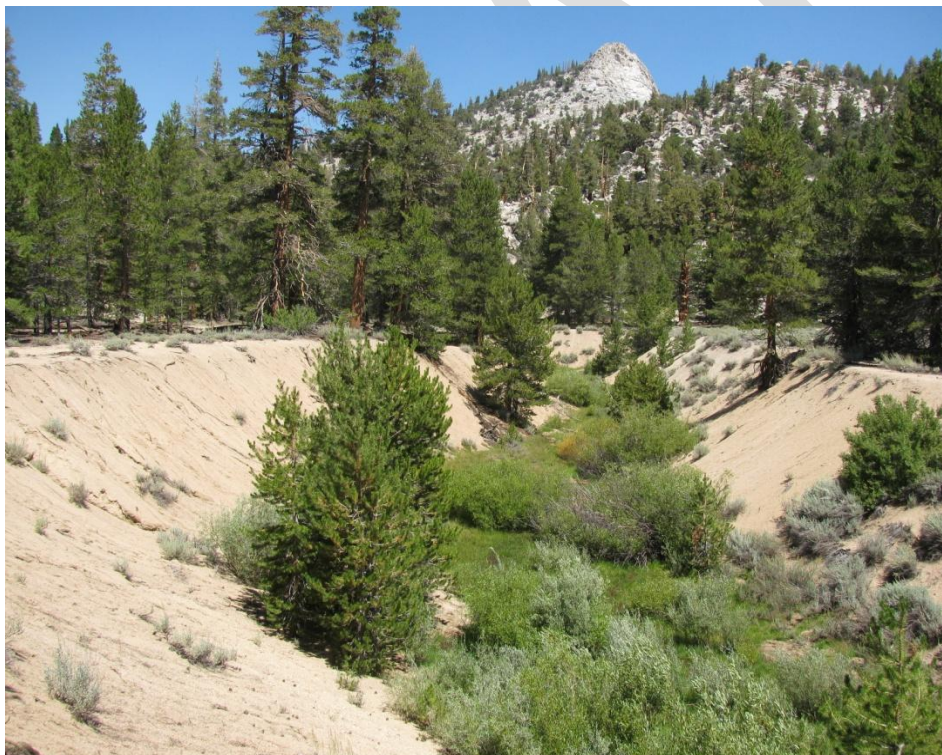
Above photo: North branch of Overholster Meadow, August 2003. Site is a large gully that runs from the gully confluence with Mulkey Creek in Overholster Meadow, caused by historic channel incision from floods and currently stabilized with recovering floodplain in bottom where riparian vegetation is filling in. HC 363 is at the top of this gully ¼ mile upstream. **Below photo:** North branch of Overholster Meadow, photo retaken August 2011. Appears that gully bottom has slightly elevated and vegetation is more robust and developed, and is exhibiting signs of stability.

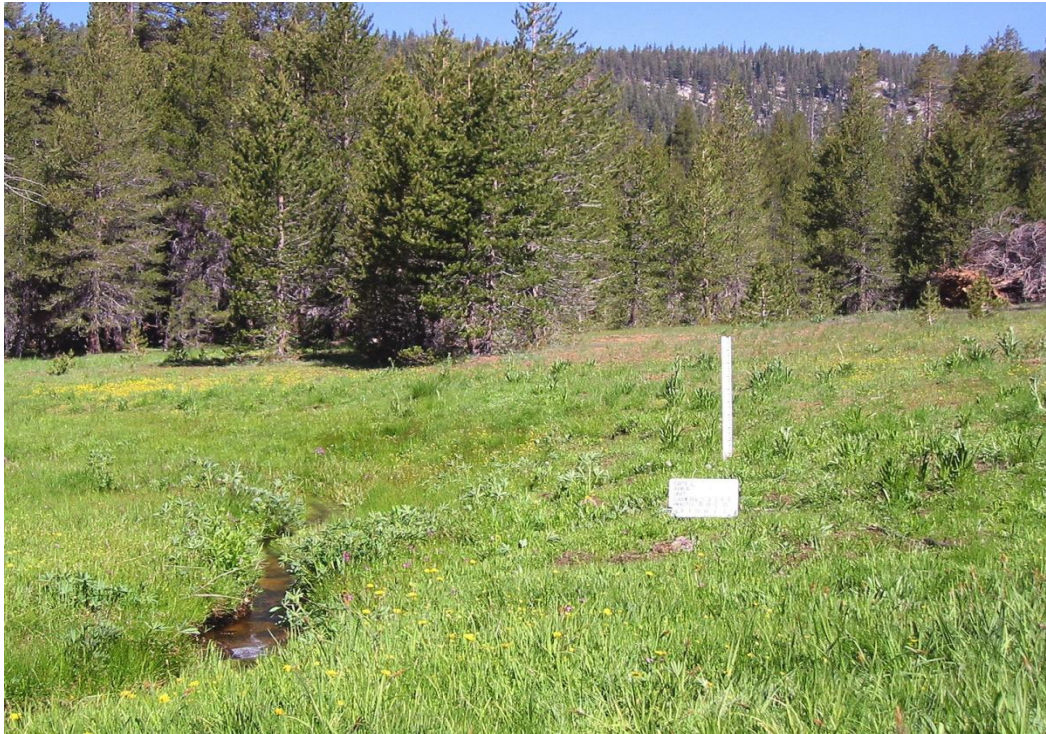
Above photo: Photo-point 308 (PP-308) Redrock Meadow, June 2003. Site is an area of punctured sod and partially exposed soil on the banks of east branch of Redrock Creek. **Below photo:** PP-308 with photo re-taken September, 2011. Most of the disturbed sod areas have re-vegetated, riparian vegetation is more robust and the site is stable.

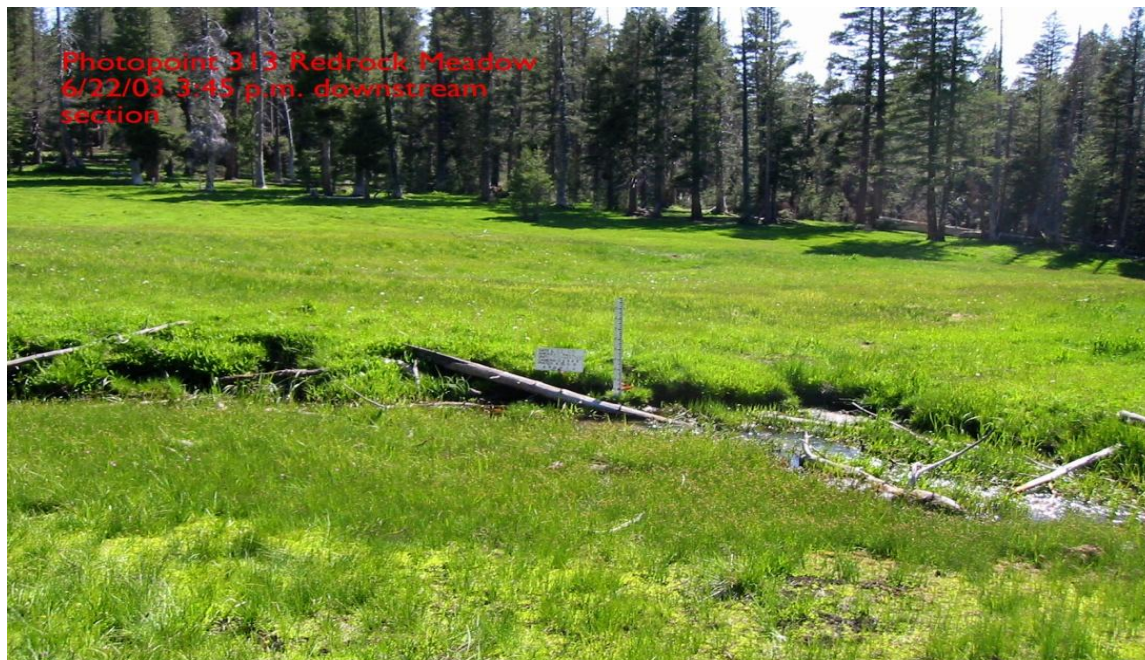
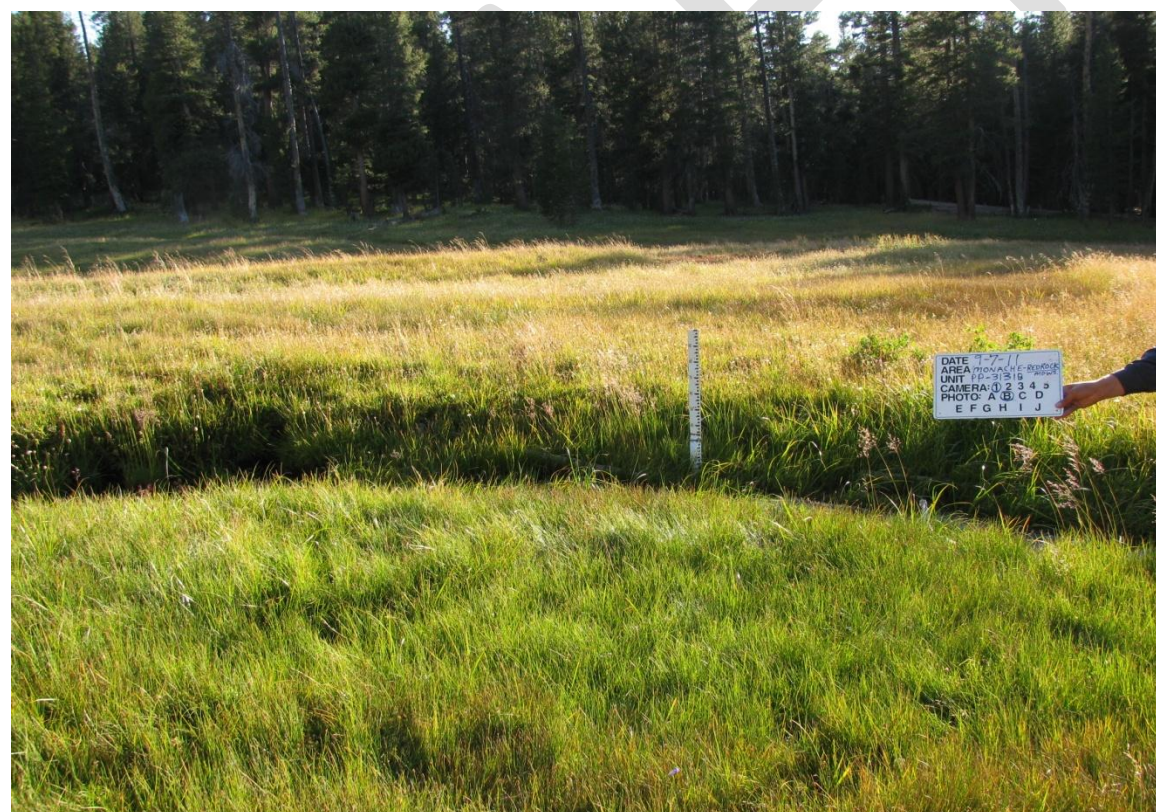
Above photo: Photo-point 313-1B (PP-313-1B), Redrocks Meadow June 2003. Site is a stream bank meander with several nick points caused by cattle trailing. Channel is moderately over-widened as a result of bank erosion. Logs and branches were placed by resources crews to discourage cattle trampling. **Below photo:** PP-313-1B with photo re-taken September 2011. All nick points have mostly filled in with organic soil and new vegetation. Logs are now entrained into stream banks adding to stability and channel has moved towards normal width and depth. Riparian vegetation is more robust.

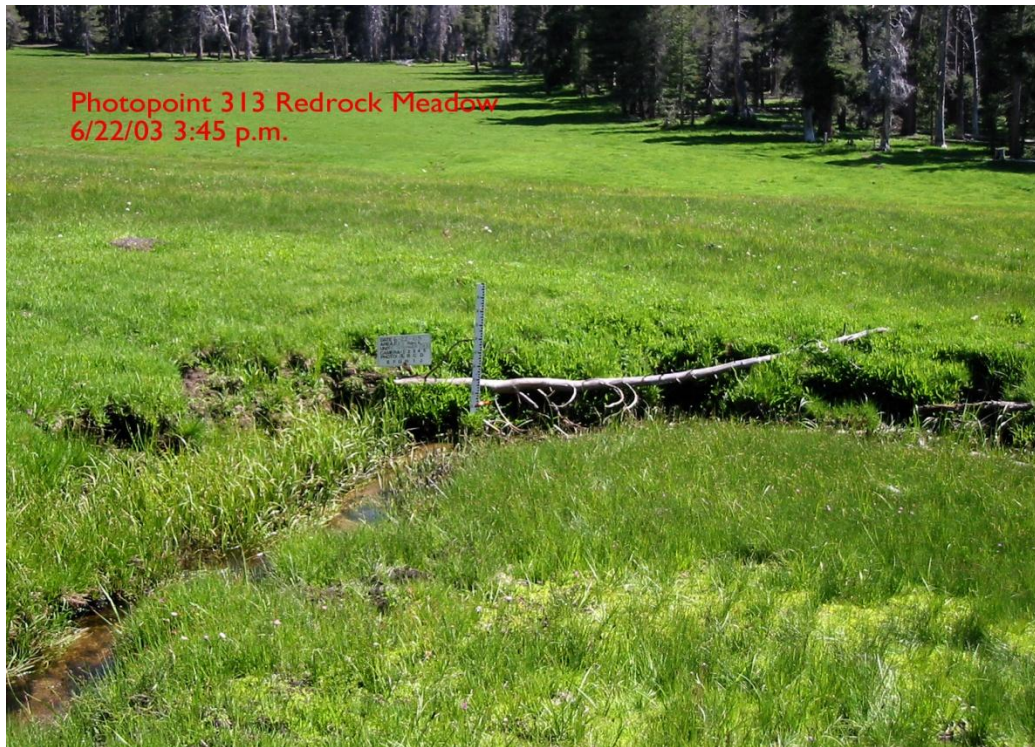
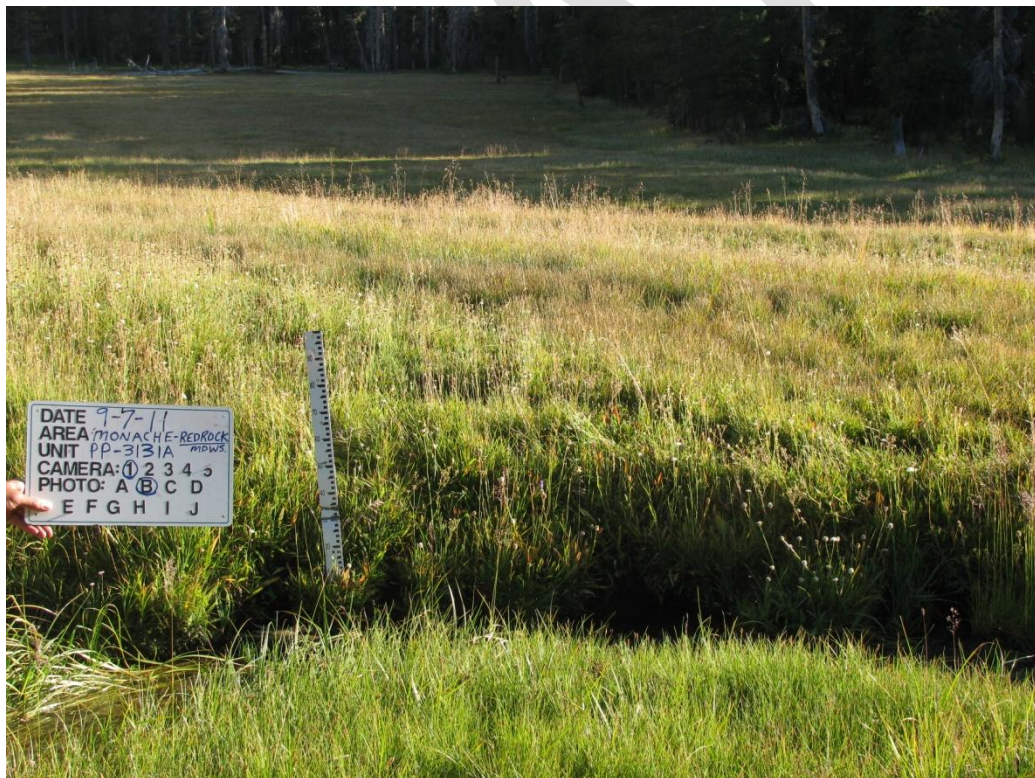
Above photo: Photo-point 313-1A (PP-313 1A) Redrock Meadows, June 2003. Site is a degraded meander bend with bank nick-points along a stringer. **Below photo:** Most of the eroded stream bank has filled in with robust vegetation and is stable, channel has narrowed.

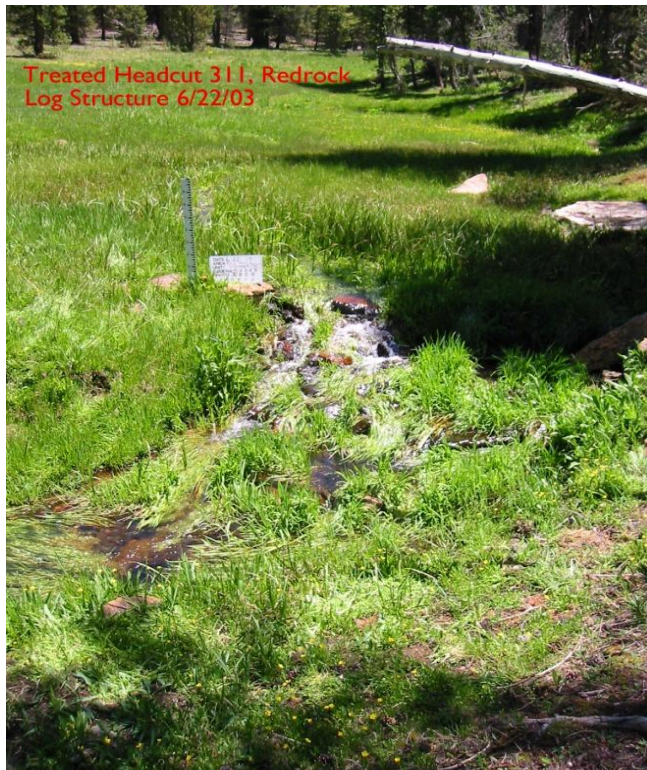
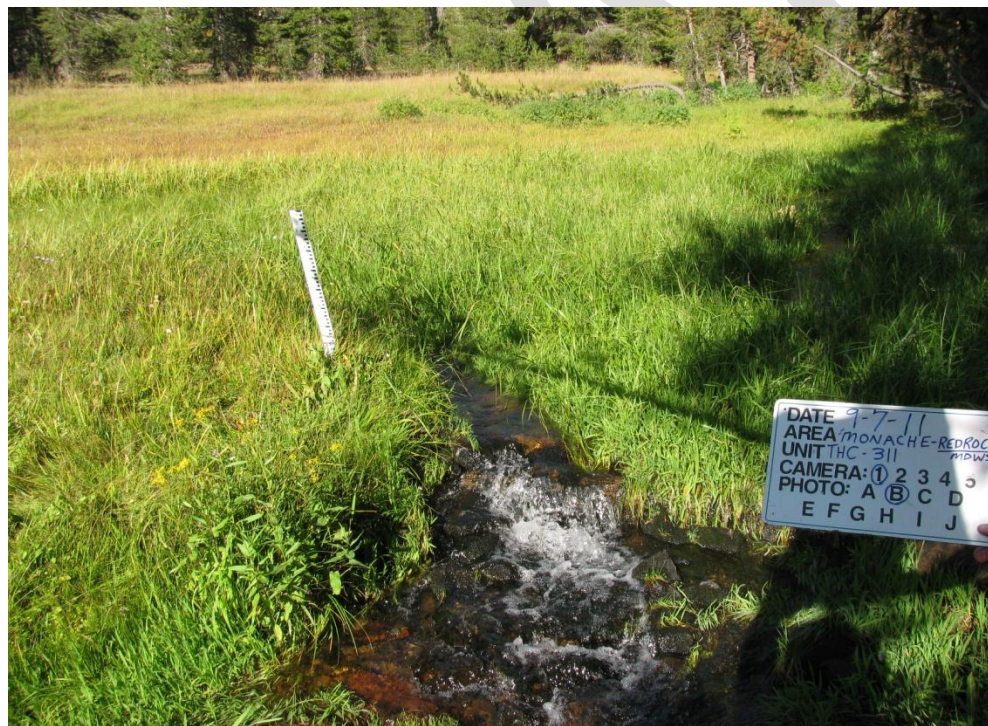
Above photo: Treated Head Cut 311 (THC-311) Redrock Meadow June 2003. Site is an older log structure (check dam) and rock spillway built to arrest head cutting and to capture sediment to build incised channel upward, built in 1950's. Treatment at the time was effective, channel is defining itself. **Below photo:** THC-311 photo re-taken September 2011. Structure is intact and effective, vegetation has taken hold and stream channel has defined a natural course less dependent on the structure. Riparian vegetation behind the log dam has filled in and robust. Site is very stable.

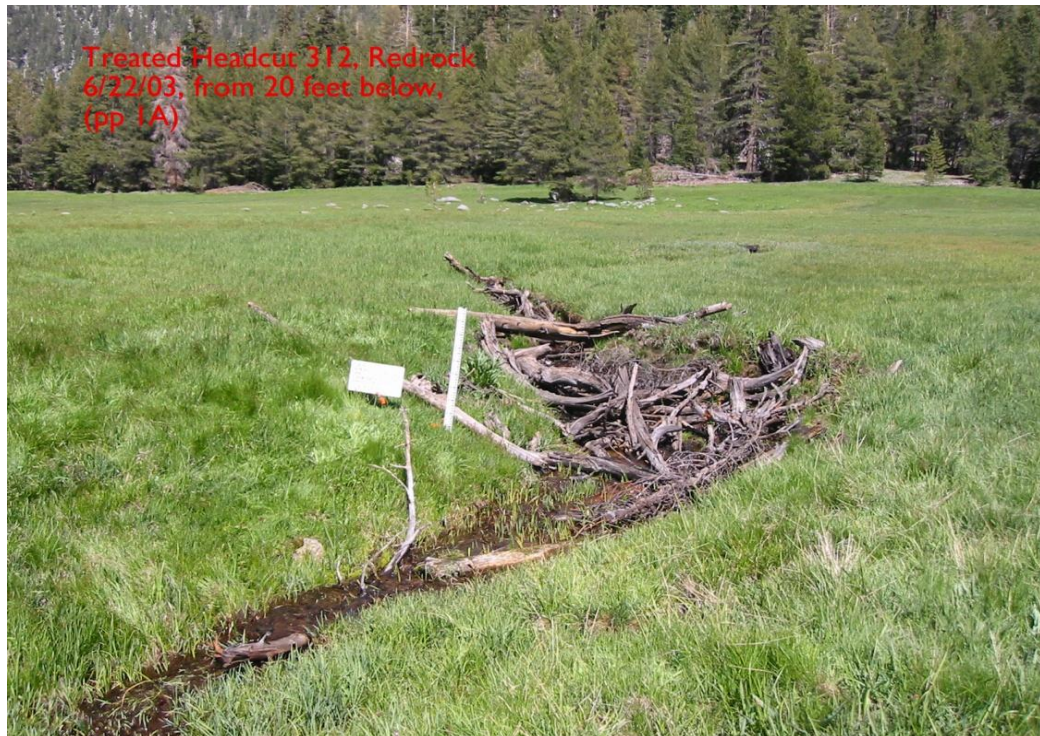
Above photo: Treated Head Cut 312-1A (THC-312-2a) Redrock Meadow, photo taken June 2003. Site is a channel with a series of small headcuts treated with limbs/branches placed over headcuts to slow erosion and to discourage cattle trampling. Stream bank edges are showing moderate erosion. **Below photo:** THC-312-1A with photo re taken September 2011. Bare soil areas on banks have re-vegetated, the channel has narrowed and woody materials have become structured into the soil and vegetation.

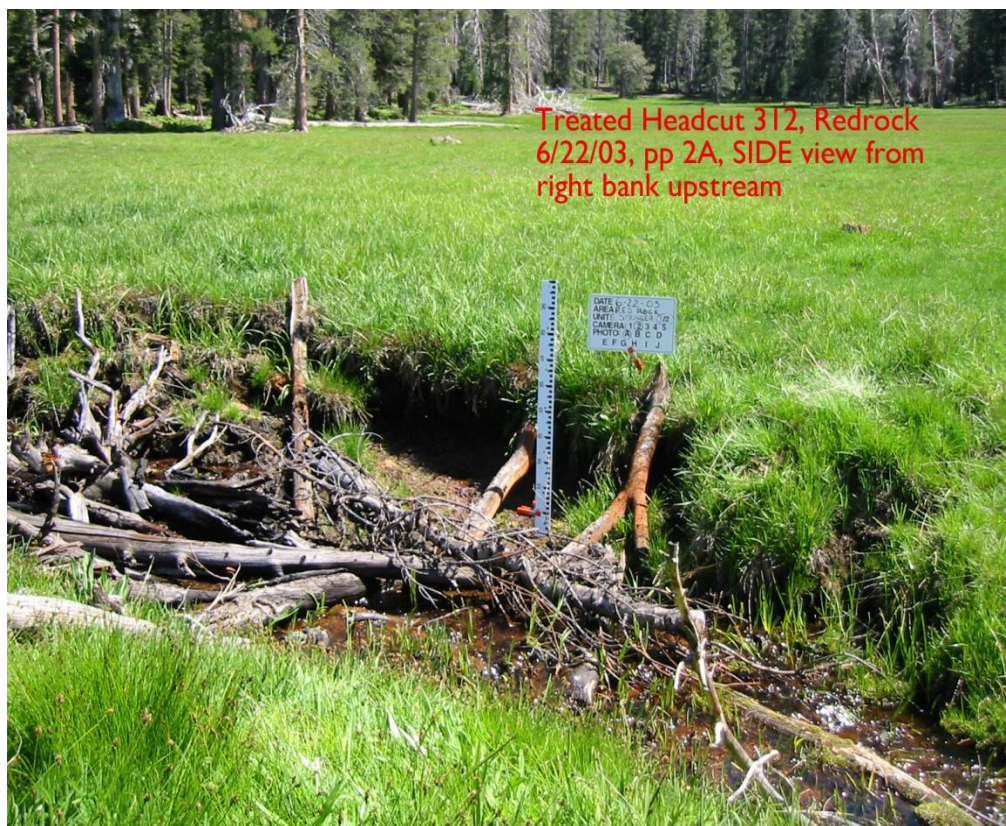
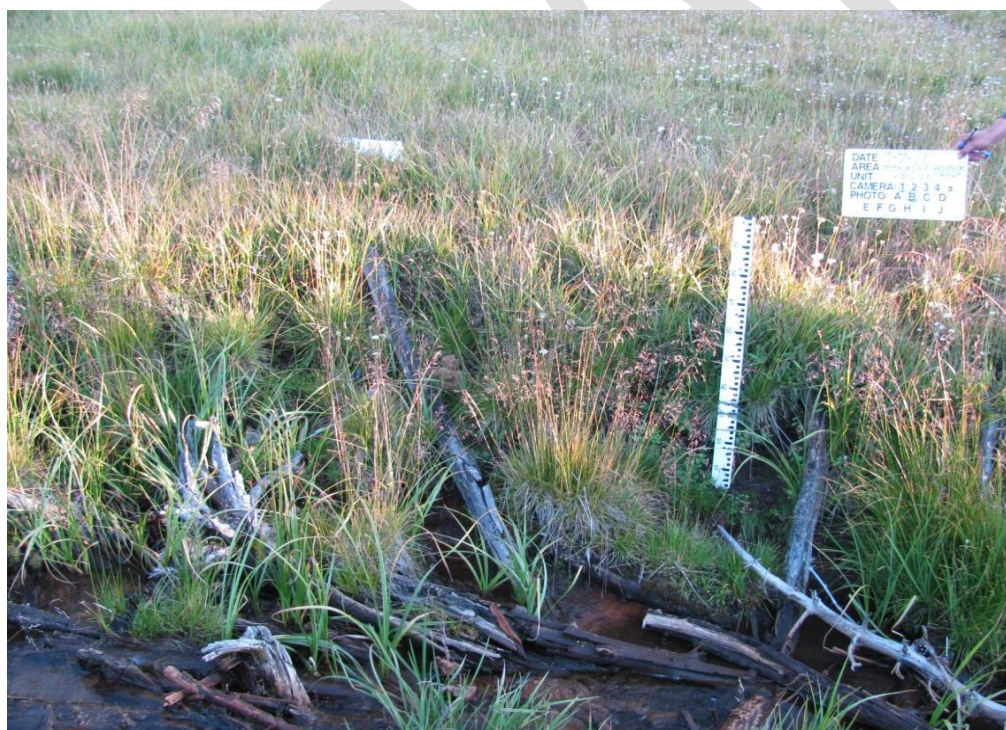
Above photo: Treated Head Cut 312-2A (THC-312-2A), Redrock Meadow photo was taken June 2003. A moderate amount of lateral scouring of stream banks caused by branching in channel has occurred with bare soil showing.

Below photo: THC-312-2A with photo taken September 2011. Raw stream banks have filled in with vegetation and bare soil areas have diminished. Erosion has mostly ceased.

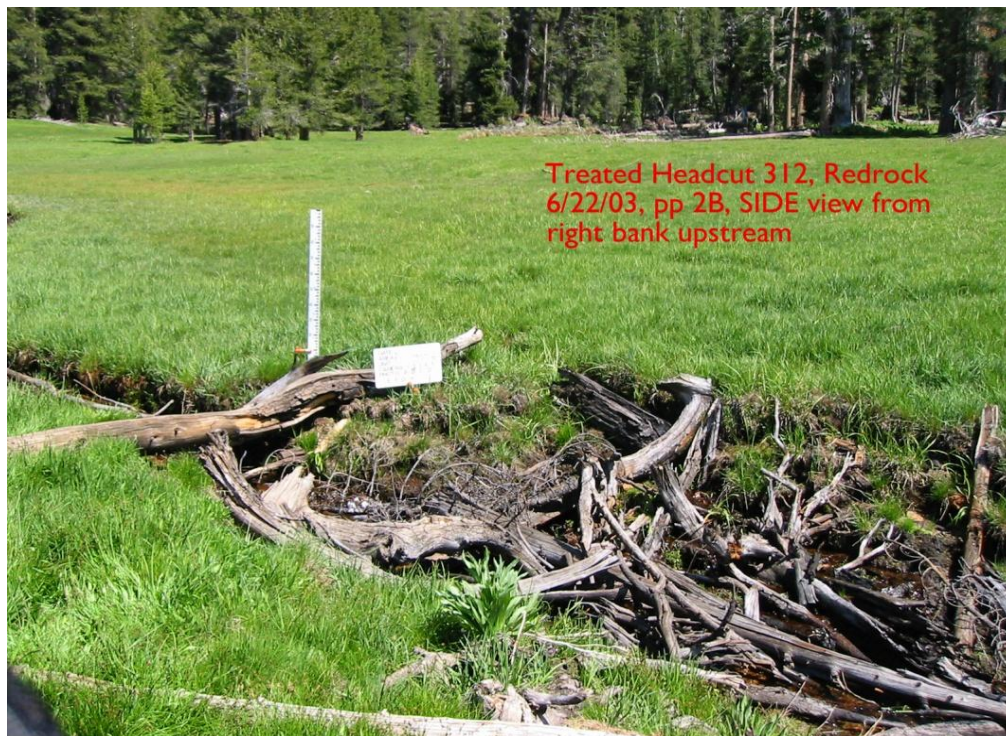
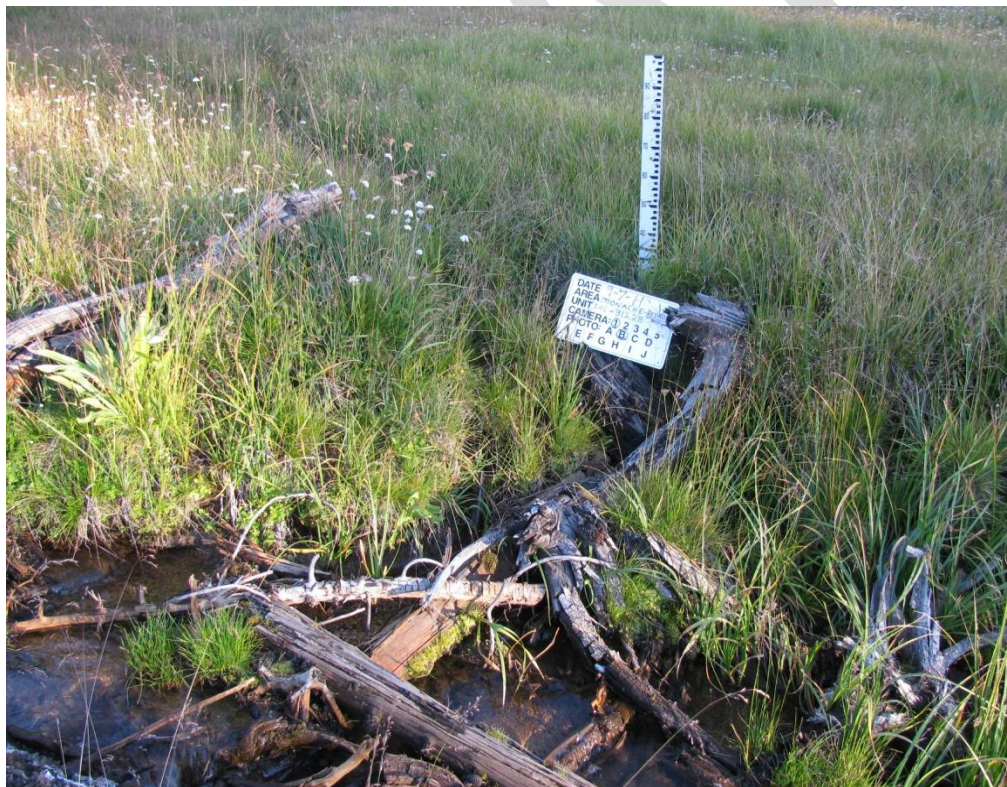
Above photo: Treated Head Cut 312-2B (THC-312-2B) Redrock Meadow with photo taken September 2011. Site is a small head cut treated with wood branching to slow erosion and discourage cattle trampling. **Below photo:** THC-312-2B with photo re-taken September, 2011. Exposed soil areas on stream banks have stabilized with vegetation and erosion has slowed. Vegetation is more robust.

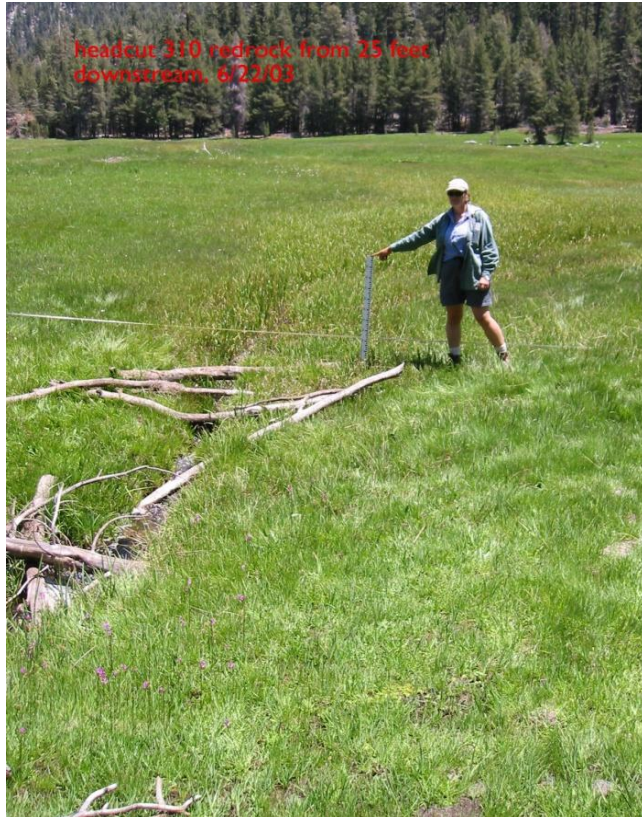
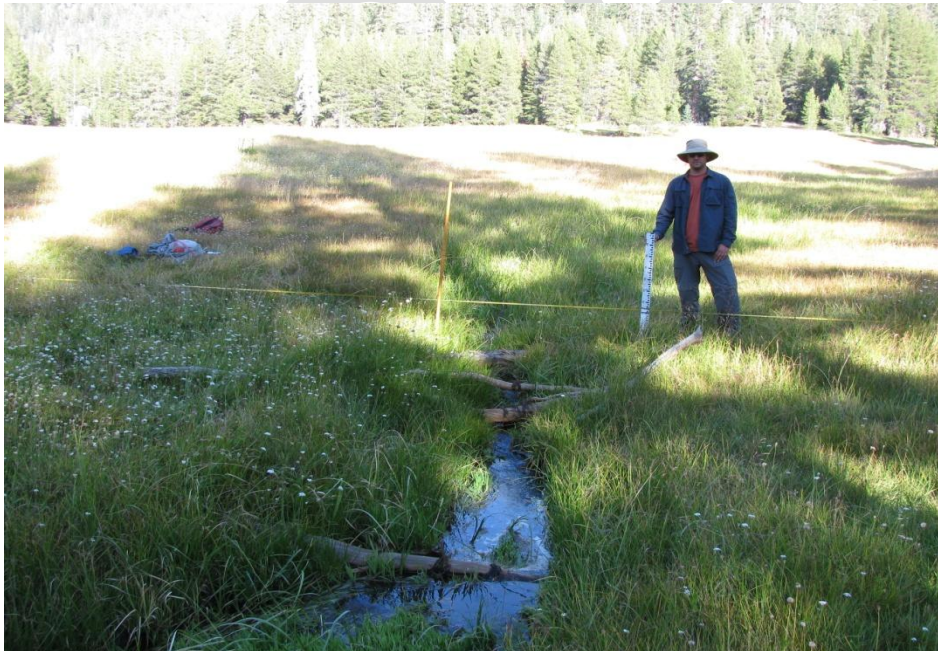
Above photo: Head Cut 310, (HC-310) Redrock Meadow June 2003. The headcut was caused by a failed rock chute treatment of a previous headcut. The headcut was starting to migrate above old structure.

Below photo: HC-310, Redrock Meadow with photo re taken September, 2011. Headcut has not migrated and does not exist as before, vertical HC face has sloped back and adjusted to natural grade and channel has stabilized with robust vegetation. The site has stabilized, no need for treatment.
